The Ramsgate Society
Smeaton Dry Dock, Ramsgate
Condition Survey

248135-ARP-RP-CM-0001

Final | 6 April 2016

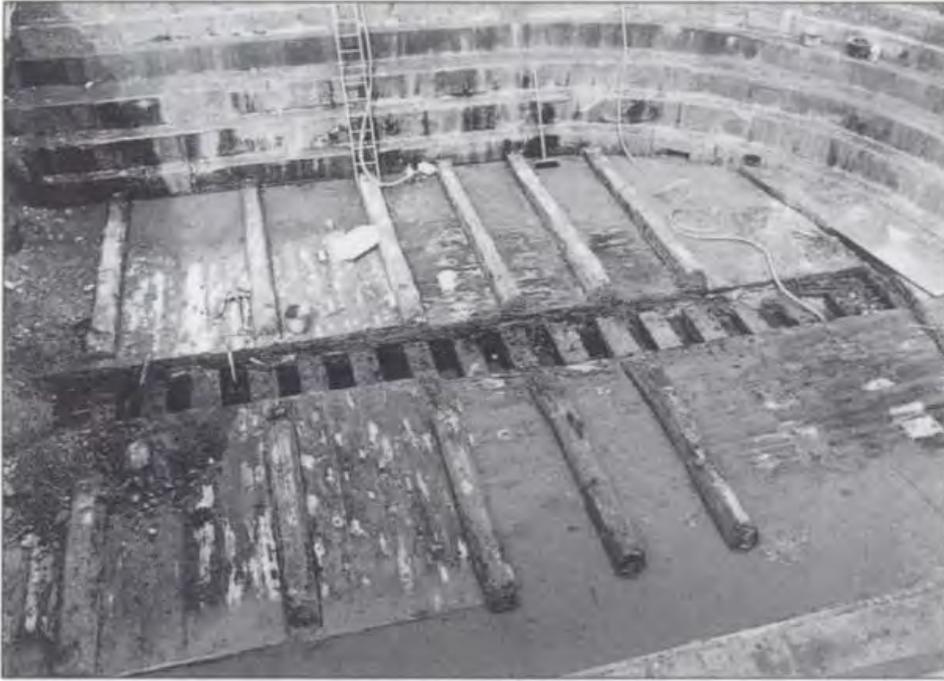
In 1983 works were carried out to restore and reveal the original dry dock structure. The restoration works exposed the timber beams of the dock floor which appeared to be in relatively good condition considering their age see [Figure](#)

3. This relatively good condition is thought to be attributed to their constant saturation in seawater and silt.

Figure 3 - Photograph from 1983 restoration works on the dry dock

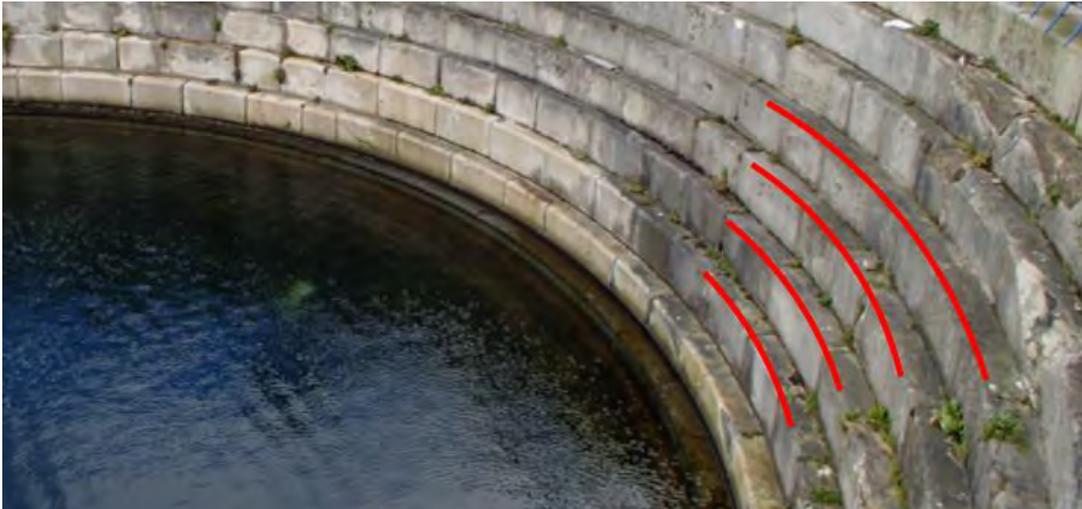
Based on visual appearance alone, the dock appears to have variable conditions around its perimeter. With various defects and damage observed as detailed below. There are no visible signs of significant current movement of the dock walls although there are signs of previous historic movement. The horizontal alignment of the walls appears to be as originally intended. The curved section at the rear of the dock is geometrically regular as seen in [Figure 5](#). There is however evidence of localised vertical movement of the northern section of the dock wall.

[Figure 5](#) - Curved Stonework Alignment

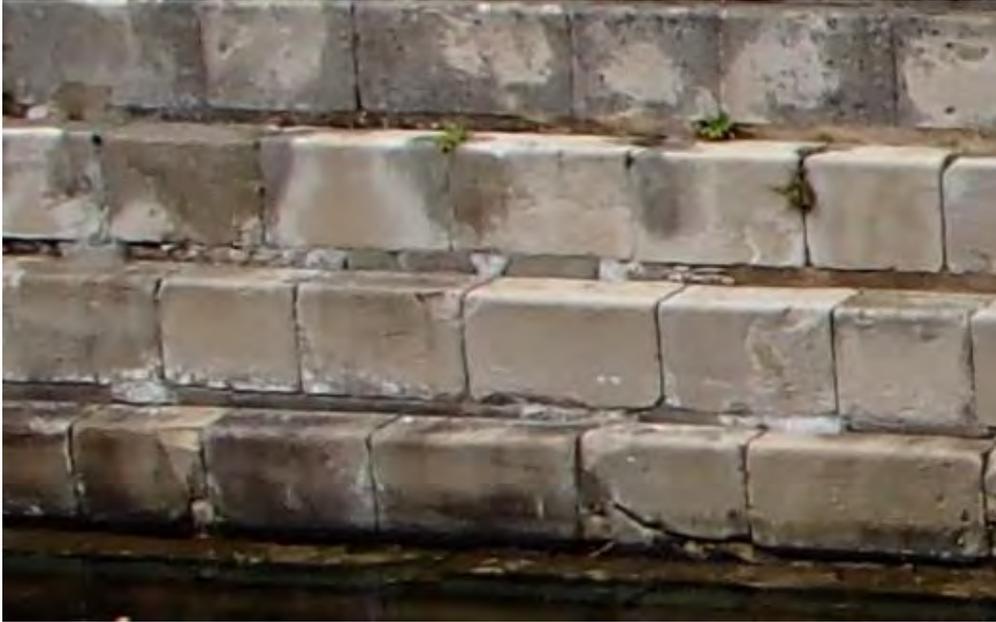
There is evidence on site of possible indications of past vertical movements of the stone courses; see [Figure 6](#). It is clear that the bedding joints, which elsewhere within the dock are very tight and regular, have opened up and there are now significant horizontal gaps between the blocks. It can be seen that several attempts to plug these gaps with grout and during the visit to site Michael Cates recalled the plugging attempts with wooden pegs.

Figure 6 - Evidence of vertical movement of courses on the North side of dock with grout repairs visible

The cause of the differential movement of the north wall blocks could be due to a number of reasons. Whilst the exact reason is not known, it could be due to uplift from the bed of the structure and then settlement or due to the scour of the sediment below the wall and erosion of the stone caused by the flushing and jetting through the wall, as shown in [Figure 7](#).

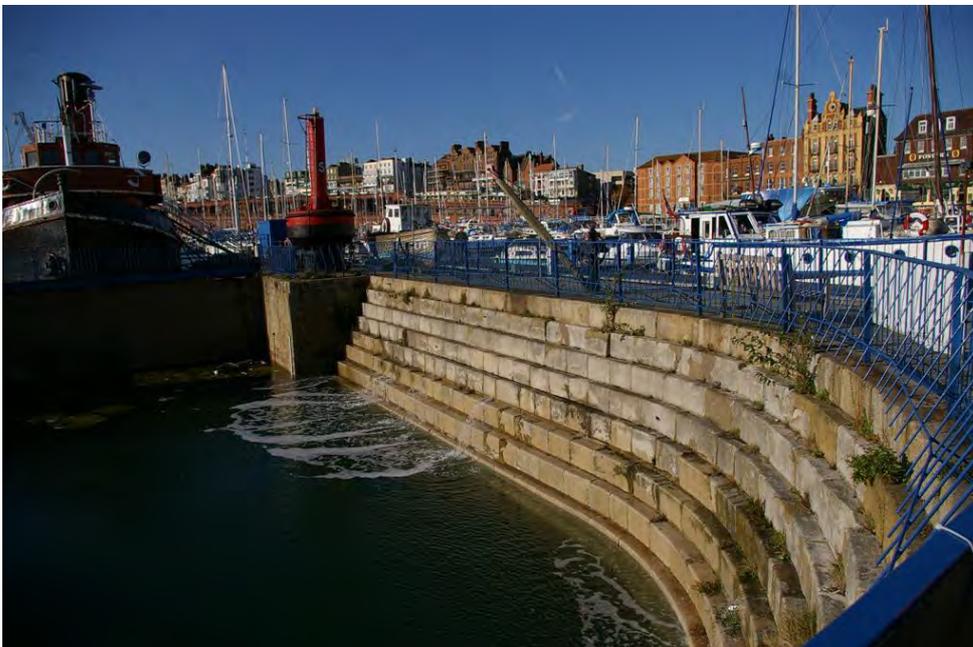
Figure 7 - Leaking North Wall 14th November 2007

When the dock was operational, it is likely that these gaps caused extensive leaking of the dock and attempts were made to establish a watertight seal. The differential pressure between the outside and inside of the dock when it was dry may have led to failure of these repairs in the North wall from which the leaks

were propagating. Allowing the structure to remain pumped out with these leaks through the masonry joints would have induced erosion from the flushing of water and sediment through the walls. This may have eroded the core material of the North wall leading to lack of fines and voiding which may have caused further damage.

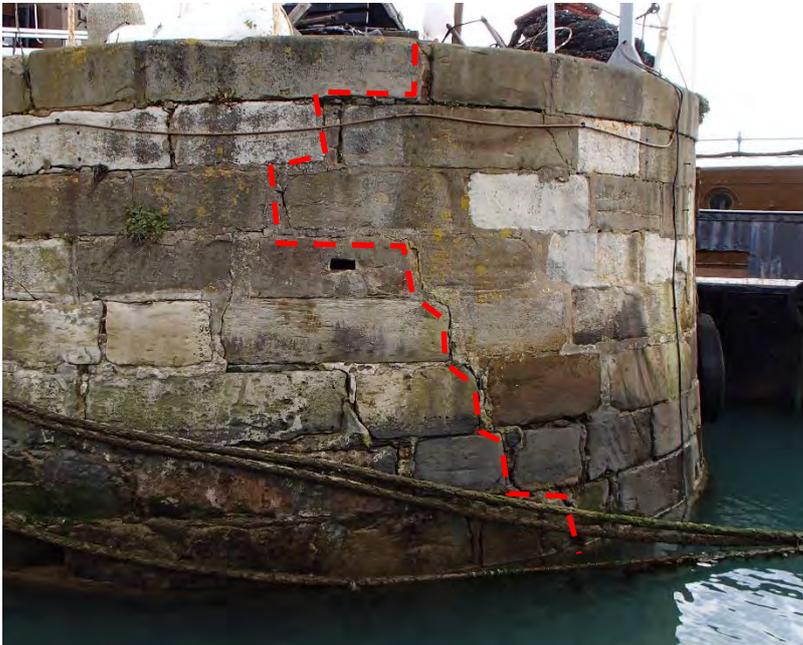
As shown in [Figure 8](#) there has been displacement of part of the roundhead as evidenced by the continuous crack through the structure.

[Figure 8](#) - Movement of Northern Wall Roundhead

The cause of the apparent displacement of this section is unclear and would require further investigation and monitoring.

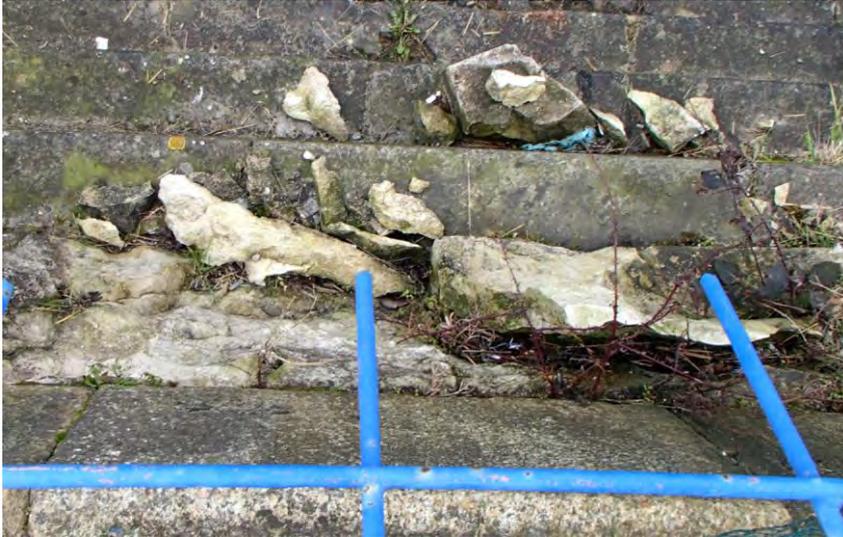
There is evidence of weathering and degradation of the stones in the wall as shown in [Figure 9](#). Within the dock this appears to be localised and small scale.

Figure 9 - Southern Wall Stone Degradation

The weathering and degradation is potentially caused by mechanisms such as freeze-thaw or plant growth. Within the dock at this time, the degradation is unlikely to have significant stability or structural implications.

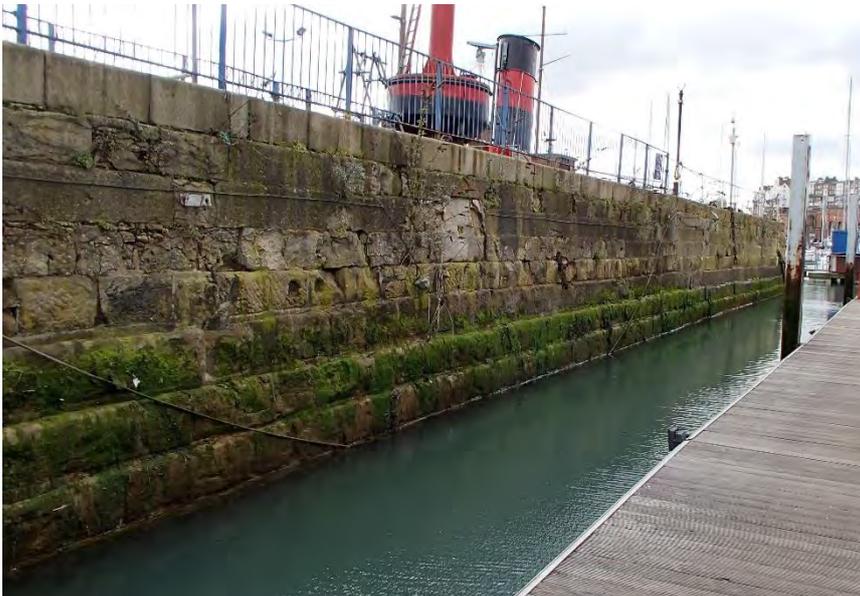
However, on the marina side of the Northern Wall the degradation is more severe and it appears whole blocks have been affected.

Figure 10 - Marina side of Northern Wall Stone Degradation

These blocks have become very permeable and fractured meaning that any works in this area would be difficult, risky and relatively expensive.

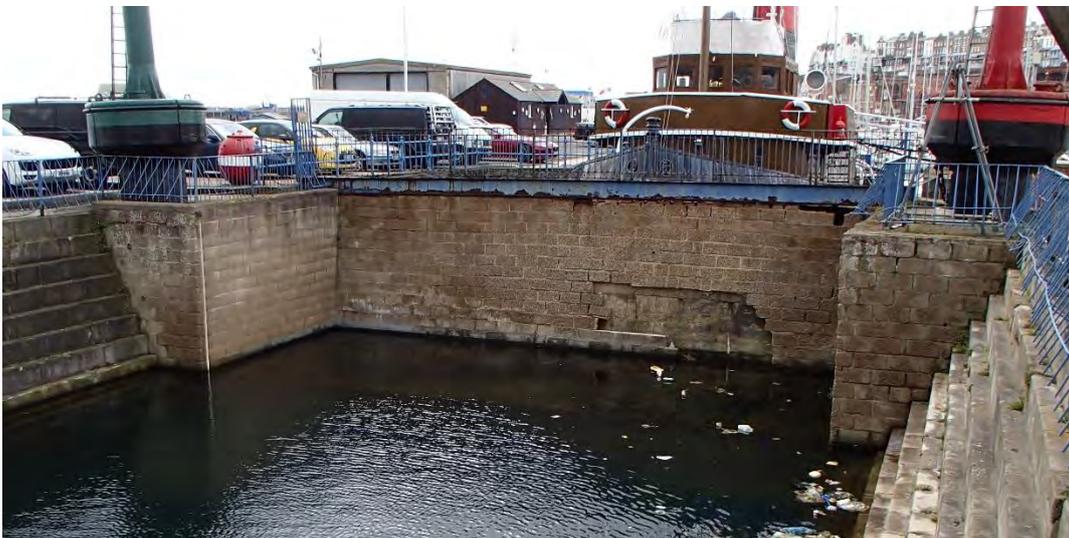
The condition of the dividing wall is poor with a large section of the block facing having failed and fallen into the dock. The condition of the reinforced concrete behind the non-structural facing appears to be satisfactory although details of the construction of the dividing wall are unknown.

Figure 11 - Dividing Wall looking West
