The Ramsgate Society
Smeaton Dry Dock, Ramsgate
Condition Survey

248135-ARP-RP-CM-0001

Final | 6 April 2016

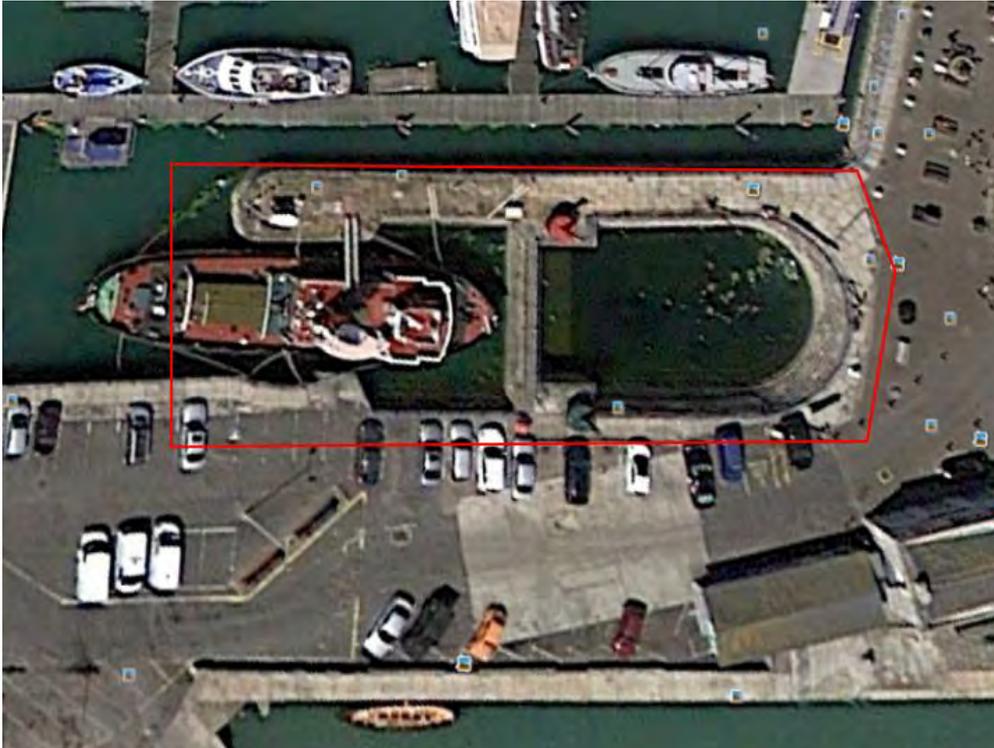
[Figure 1](#) - 2013 Aerial photograph of Smeaton Dry Dock Ramsgate © Google 2016

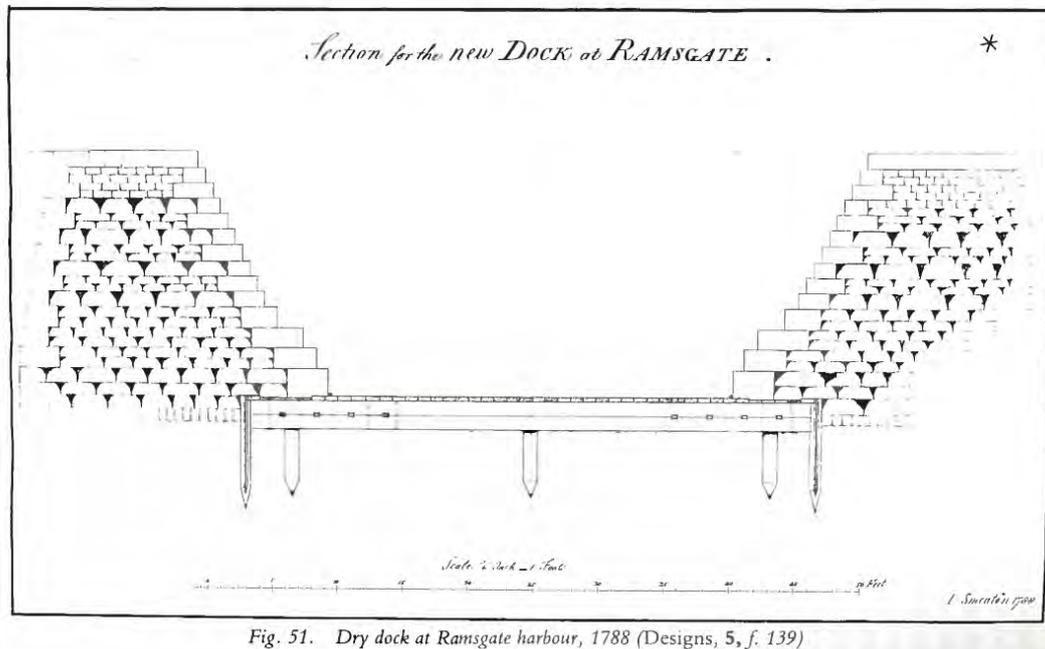
the dock as shown in [Figure 2](#). According to historical sources, this option was subsequently built and is thought to have existed to the present day.

[Figure 2](#) - Smeaton's 1788 Design for the Dry Dock [3]

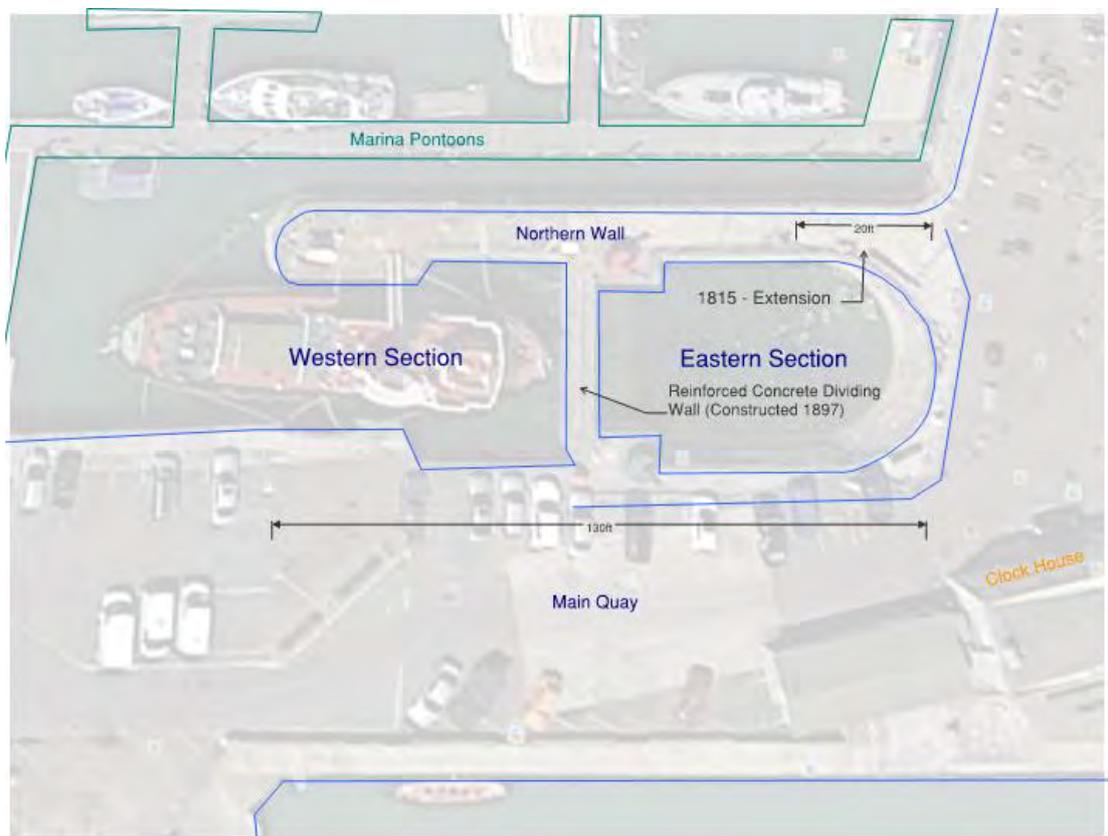
Figure 4 - Dry Dock General Arrangement

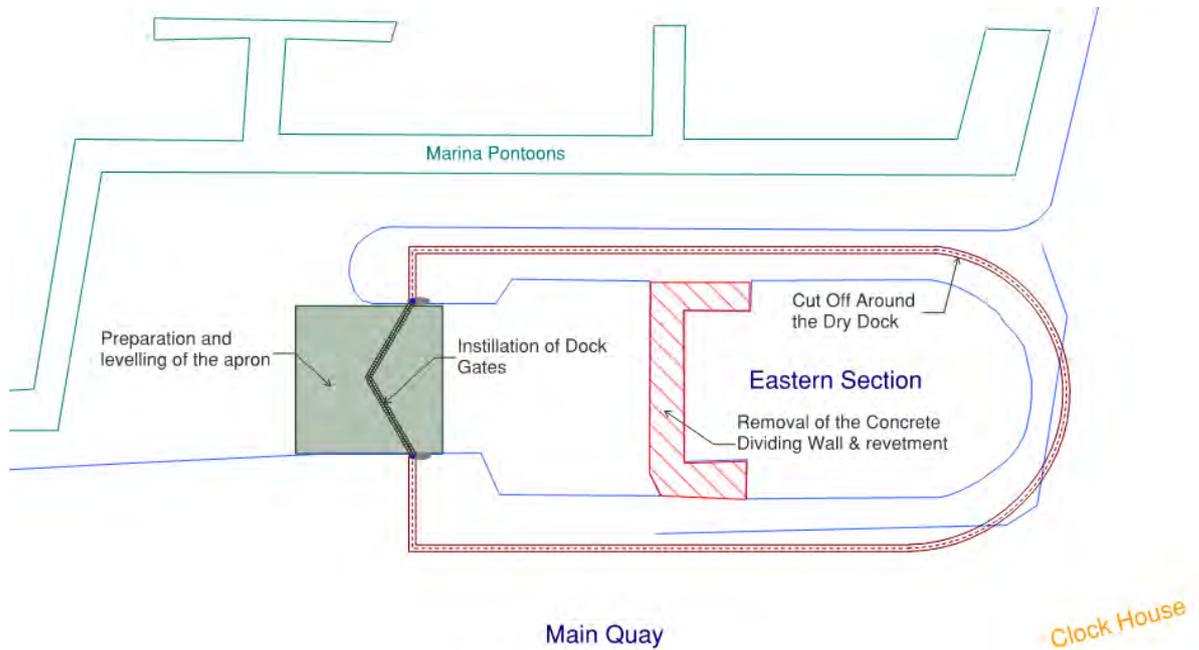
The cut-off could be formed by injection grouting, sheet piles or a diaphragm wall. As indicated in Figure 12, the services that run around and up to the dock may require re-routing and diversion.

Figure 12 - Plan of works for dry dock reinstatement

A cut-off would create an impermeable perimeter around the dock to reduce water ingress from the surrounding ground, water bodies and from beneath the dock from springs/streams. The cut-off would extend from existing ground level to a level below ground as required to increase the length of the flow path or to tie into an impermeable stratum.

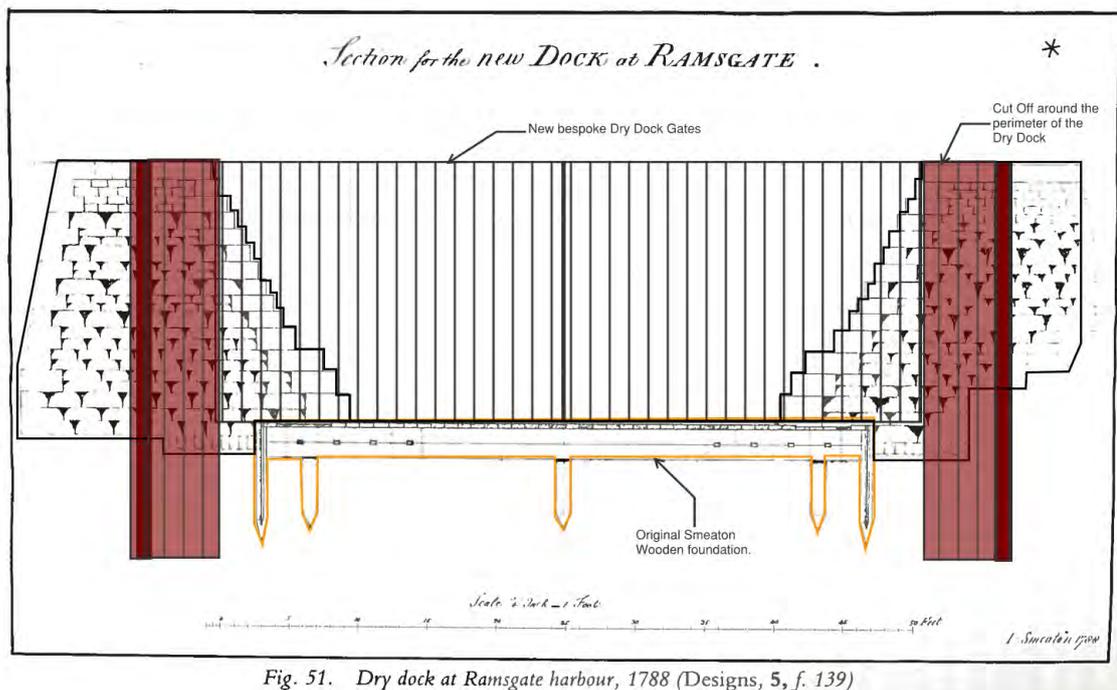
In establishing the structure back to the working dry dock status it will require the installation of bespoke dock gates. These will need to be designed to fit the geometry of the opening and works at the dock walls will be required to establish a suitable hinge, seal and interface. In order to de-water the dock there will be a significant amount of equipment both hydraulic and electrical pumps. To power the equipment, the dock will require an electrical supply.

Figure 13 - Elevation of Dry-Dock Construction Requirements

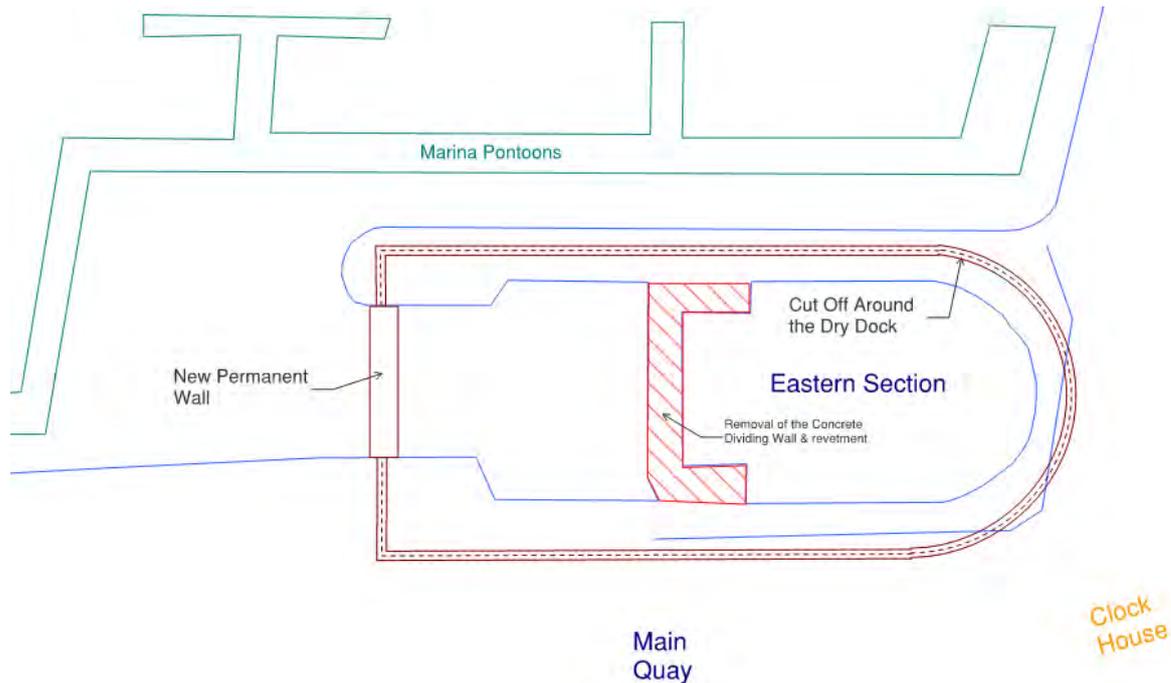
Alternatively the permanent cut-off could be installed, the existing partition removed as described above and the Cervia could be manoeuvred fully into the dry dock. Then a new solid wall across the mouth of the dock could be constructed. This would create a fully sealed dock from which the water can then be removed by a series of pumps, see [Figure 14](#).

Figure 14 - Permanent sealing of the dock

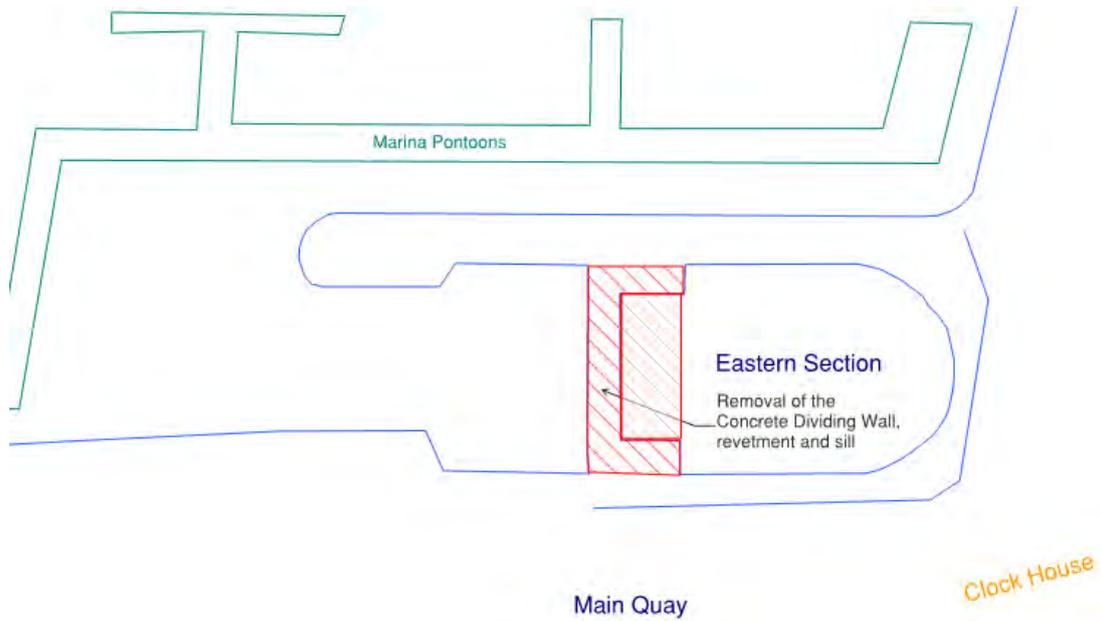
The second option looks to bring the Cervia closer to the refurbished clock house and to restore the original profile of the dry dock without seeking to dry the dock. The reinforced concrete (RC) central wall could be removed to allow the vessel to be fully moored within the dock; this is shown in the plan view of the existing wall see [Figure 15](#). The Victorian RC wall consist of a section across the dock supported by buttresses at both ends and a concrete sill.

Figure 15 - Plan view of the removal of the RC wall

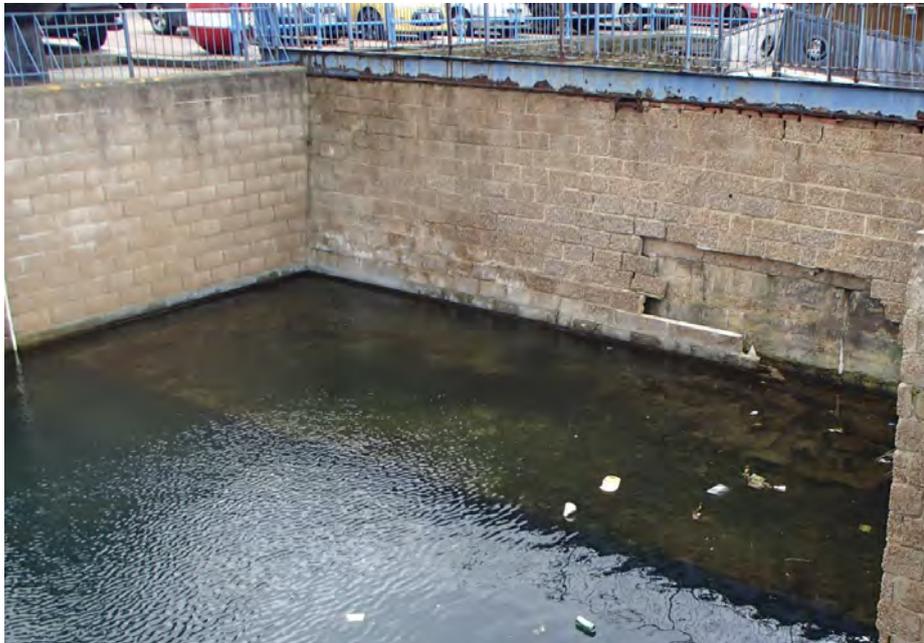
The exact volume of concrete to excavate is not clear, however it is a significant quantity that will need to be removed using large plant. There is also a steel structure that spans across the dock which will require removing see Figure 16.

Figure 16 - Reinforced concrete wall and sill (visible below water)
